AFFECTED VEHICLES:

VAUXHALL ASTRA Mk VI (J) Sports Tourer 1.7 CDTi A 17 DTJ - fabriqué entre le 2010

Symptom

Inoperative function of the climate control variable compressor.

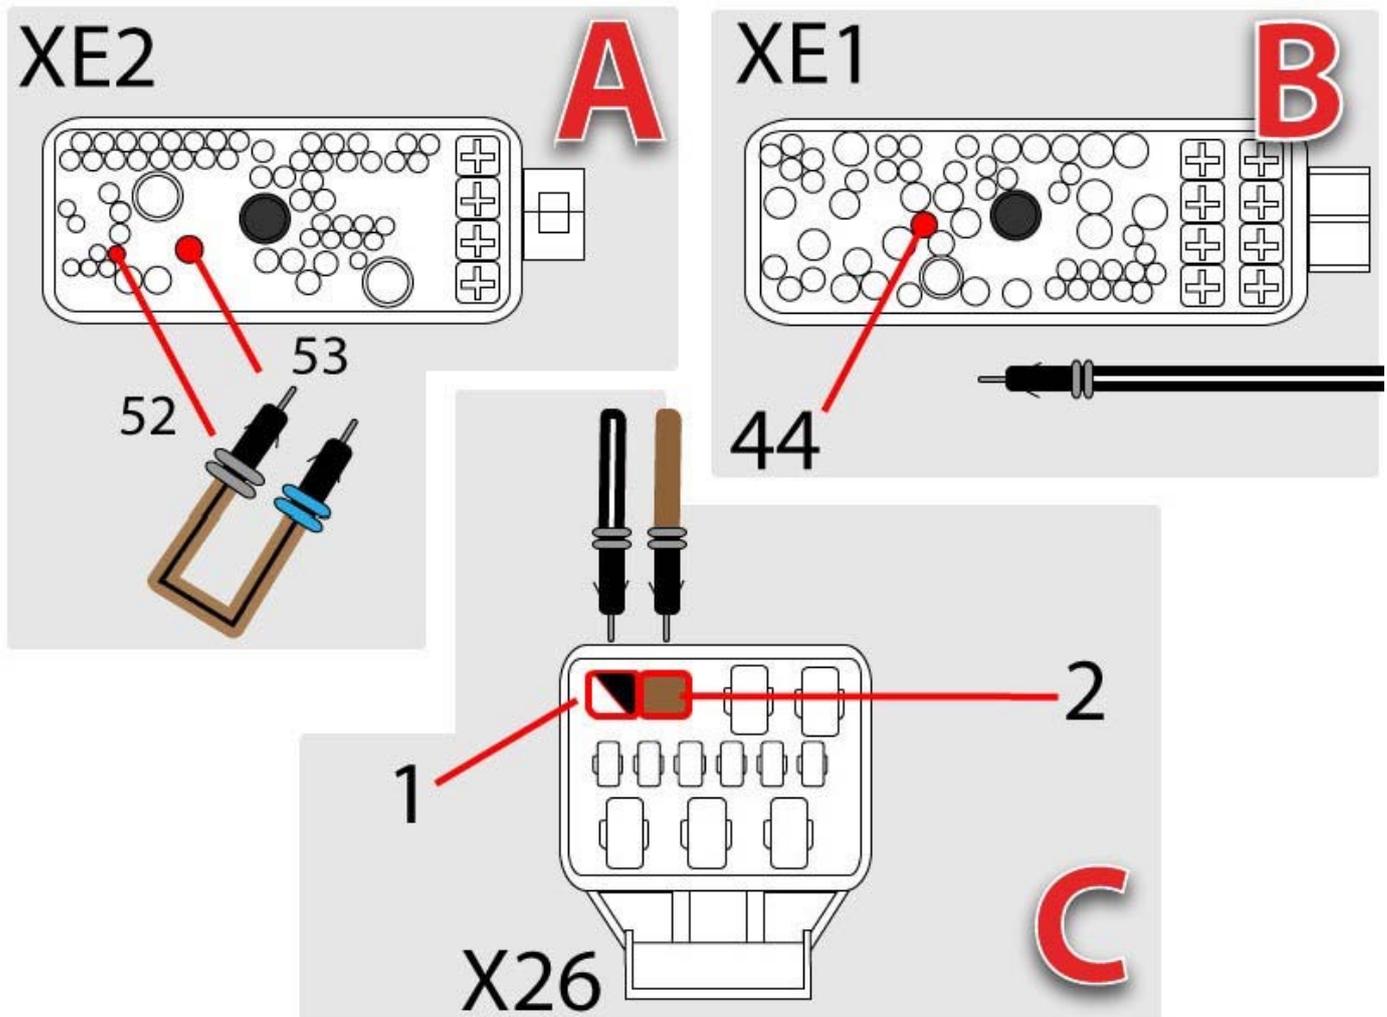
See image 1:

Internal defect of the climate control variable capacity compressor.

A - Install a jumper on connector XE2 between pin 52 (grey ring) and 53 (blue ring) with a brown/black cable from the electrical kit.

B - Make a connection to pin 44 of connector XE1 with the black/white coloured cable.

C - Remove and isolate the wires of pins 1 and 2, connect the black/white wire originating from pin 44 of connector XE1 to pin 1 of connector X26 and connect the brown wire to pin 2 of connector X26 as shown in the image.
