AFFECTED VEHICLES:

JEEP GRAND CHEROKEE II (WJ, WG) 2.7 CRD 4x4 ENF - fabriqué entre le 2001 et 2005

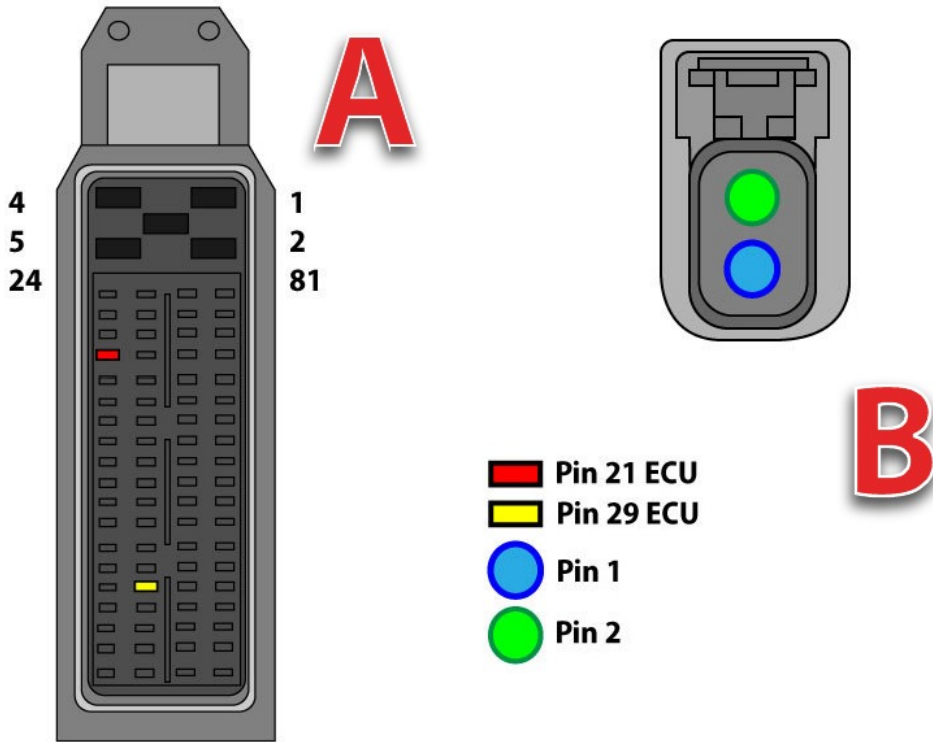
See image 1:

A - Engine control unit (ECM) connector.
B - Transfer sensor connector.

- Read the fault codes reported by the engine control unit (ECM) with the diagnostic tool.
- Delete the fault codes reported by the engine control unit (ECM) with the diagnostic tool.
- Solder a parallel wire to the transfer sensor ground wire (black/light blue wire), from Pin 21 of the engine control unit (ECM) to Pin 2 of the sensor connector.
- Solder a parallel wire to the transfer sensor signal wire (brown/ white), from Pin 29 of the engine control unit (ECM) to Pin 1 of the sensor connector.
- Correctly insulate the installed wires.
- Perform a road test.

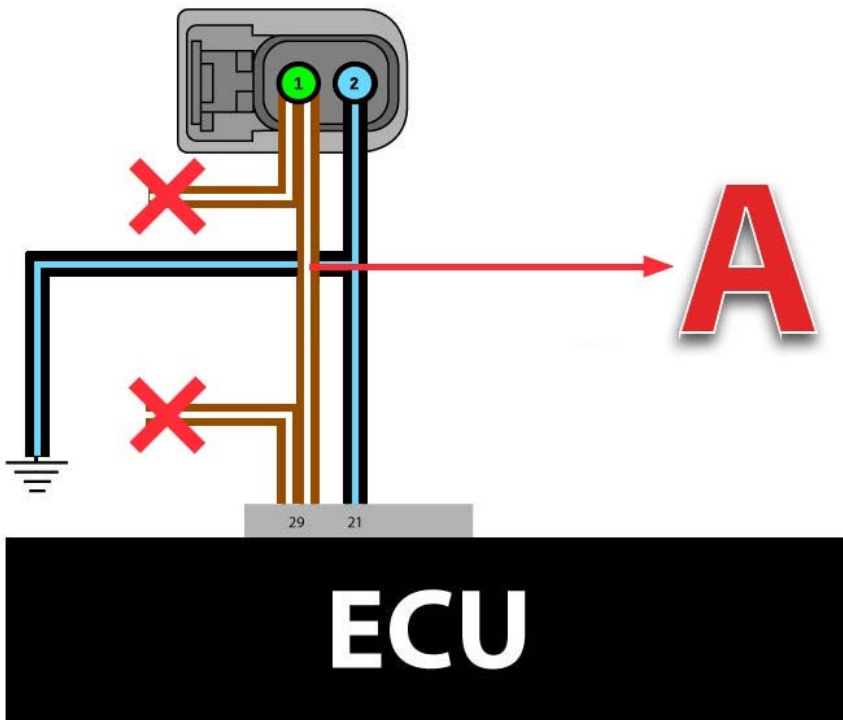
See image 2:

A - Additional parallel wire for transfer of sensor signal.

NOTE: The minimum cross-section of the extra cables must be 1.5 mm.
