AFFECTED VEHICLES

MODEL MONDEO IV

VERSION 1.6 TDCi (T1BA) 85KW 115HP 1560 Cm3

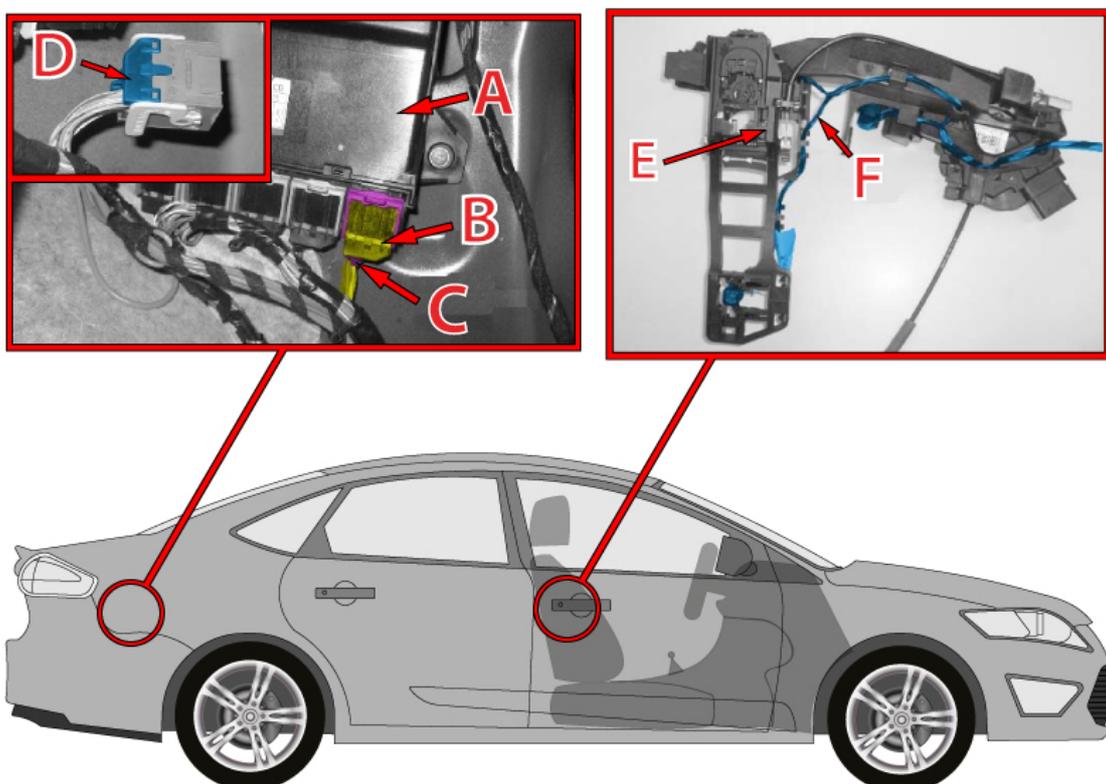
SEE IMAGE 1:

Defect in the wiring of one or several front or rear door lock actuator switches.

- A - Keyless vehicle module (KVM).
- B - Connector C5.
- C - Plastic clamp.
- D - Protector of connector C5.
- E - Wiring of the lock actuator assembly.
- F - Electrical connector of the switch.

- Remove the boot rear right trim.
 - Disconnect connector C5 from the keyless vehicle module (KVM), cut the plastic clamp and remove the protector of connector C5 (See images).

- Replace the lock assembly wiring (See image) of the affected door with a modified version if the measured resistance with the handle actuated is higher than 3 Ohms.
