**MAKE** BMW

**MODEL** 1 (F21)

**VERSION** 116 d (B37 D15 A) 85KW 116HP 1496 Cm3

### **SYMPTOMS**

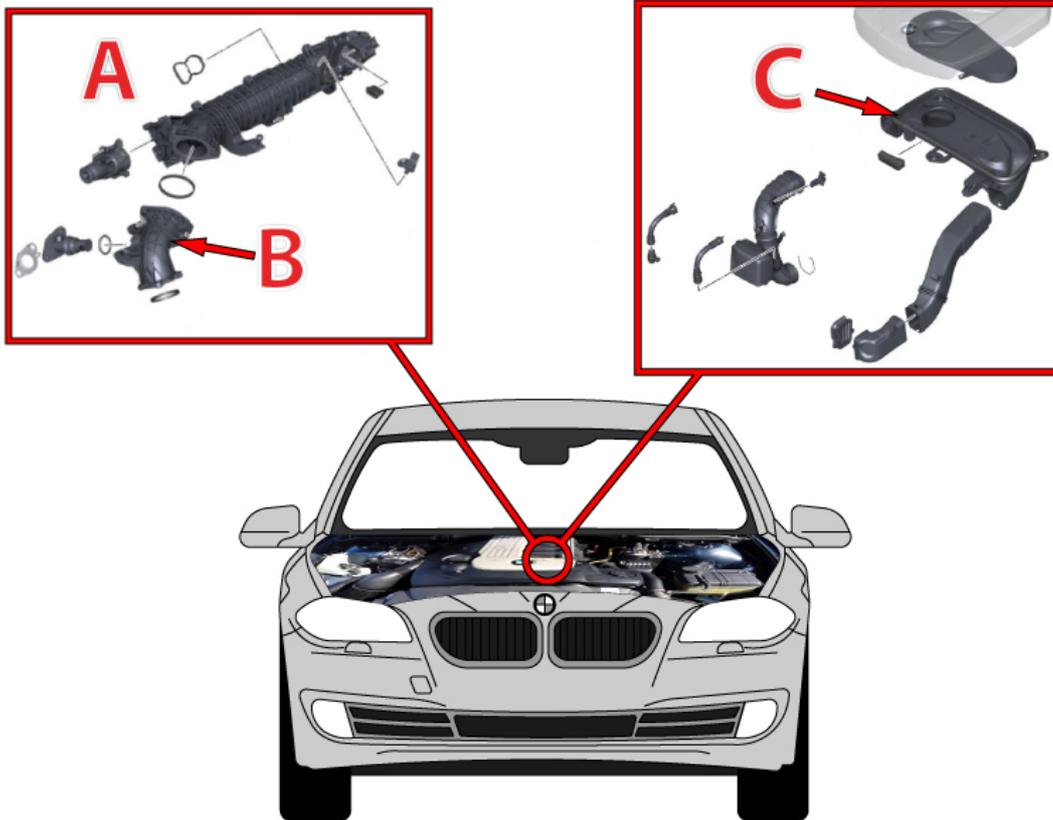
**SEE IMAGE 1:**

- In the intake pipe and intake manifold there are melted or deformed areas especially in the area of the exhaust gas recirculation valve (EGR).

- A - Air intake system.
- B - Mixing tube.
- C - Intake silencer (resonator).

- Repair the affected parts and even the engine if there are large differences between the cylinders in the result of the cylinder compression test.
- Replace the following components if NO differences are seen in the cylinder compression test:  
The air intake system together with the mixing tube (See image) if necessary.  
The exhaust gas cooler together with the exhaust gas recirculation valve (EGR) and the vacuum hoses (See image).  
The switching solenoid valve of the exhaust gas cooler bypass (See image).  
The damaged peripheral components.

- Check if the model has the latest version of the intake silencer fitted (resonator) See image.
- Replace the intake silencer (resonator) if the model is not fitted with the latest version.
- Reprogramme the engine control unit with updated software.
- Reset the injector flow correction values, once the engine control unit has been reprogrammed with updated software.

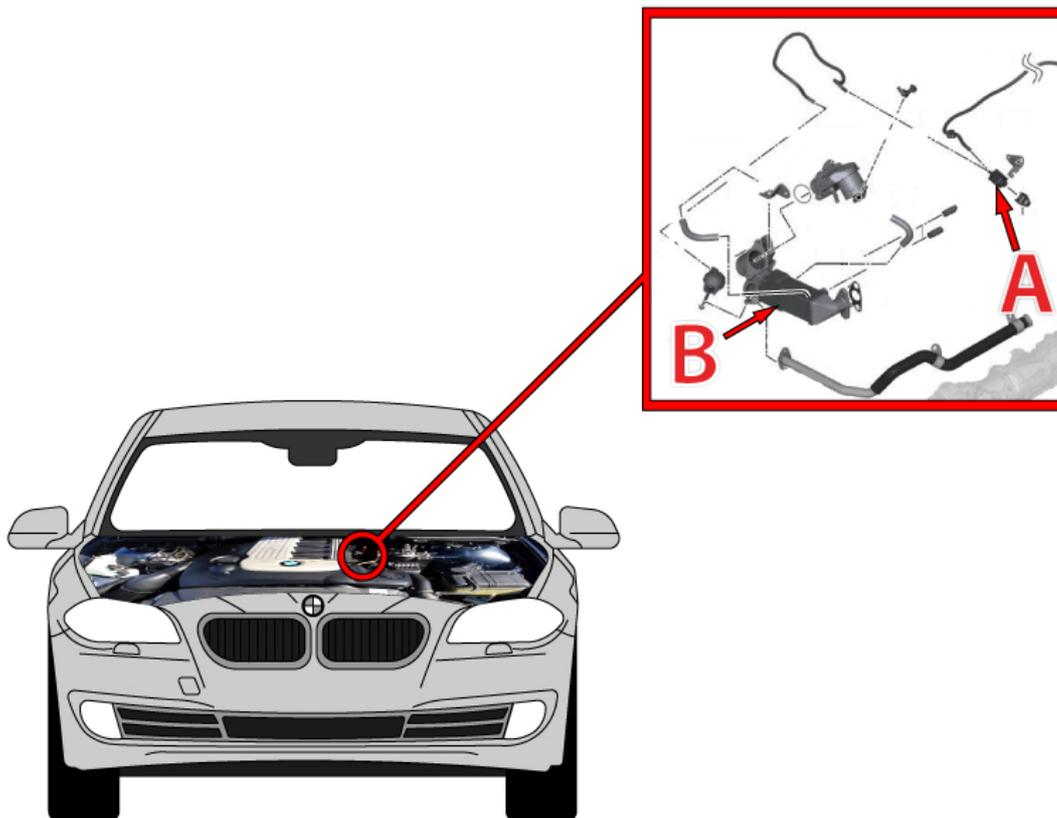
SEE IMAGE 2:

- Defect in the bypass flap of the exhaust gas cooler.

- Intake silencer (resonator).
- A - Switching solenoid valve.
- B - Exhaust gas cooler.

- Clean the intake ducts of the cylinder head if high quantity of carbon is observed.
- Check possible damage to the electrical wiring of the switching solenoid valve of the exhaust gas recirculation bypass and check its operation, repair or replace it if necessary.
