**AFFECTED VEHICLES****MAKE PEUGEOT****MODEL 308 SW II****VERSION 1.6 BlueHdi 100 (BHY (DV6FD)) 73KW 99HP 1560 Cm3**

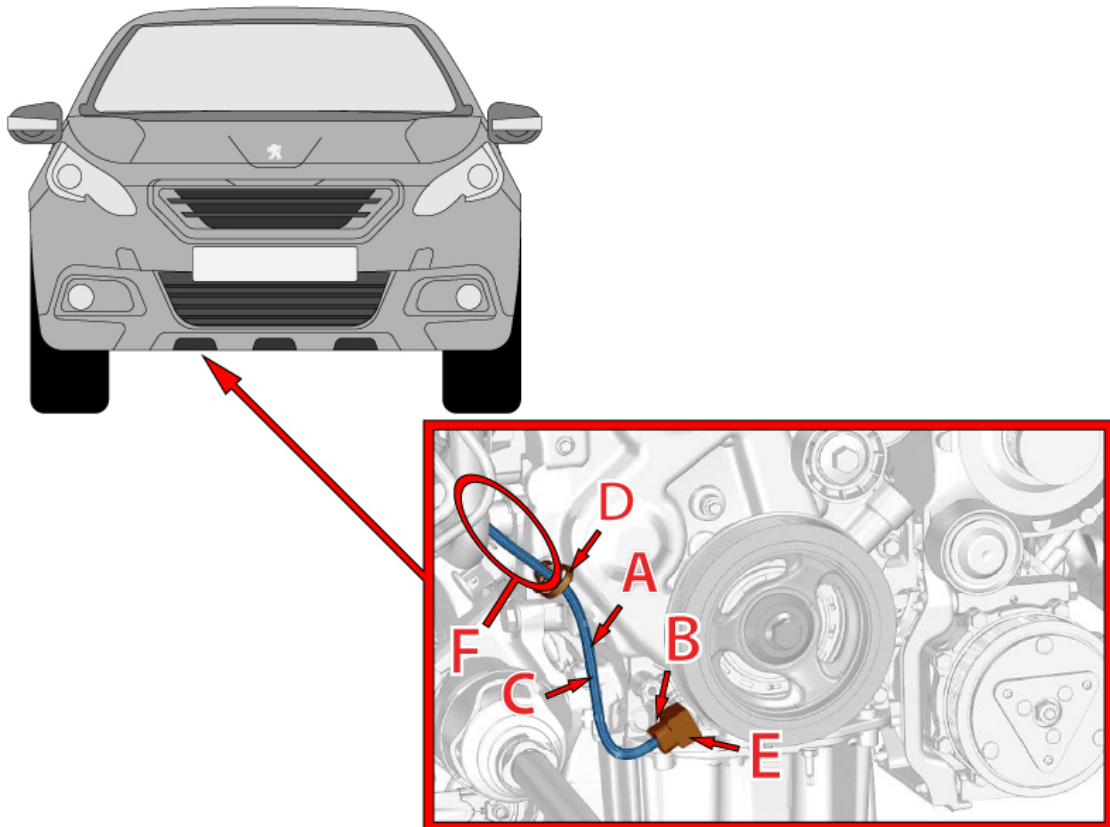
SEE IMAGE 1:

Defect in the wiring of the crankshaft position sensor.

- A - Original wiring.
- B - Crankshaft position sensor.
- C - Cut area of the wiring.
- D - Clamp.
- E - Connector of the crankshaft position sensor.
- F - Fastening area of the wiring.

- Cut original wiring A of crankshaft position sensor B in area C (See image).
- Remove clamp D and replace connector E of the crankshaft position sensor with a modified version.
- Secure the wiring in area F.
